CONNECTICUT RIVER BASIN
SOUTH BARRE, MASSACHUSETTS

SOUTH BARRE MILL POND DAM
MA 00091

PHASE I INSPECTION REPORT
NATIONAL DAM INSPECTION PROGRAM

AUGUST 1978

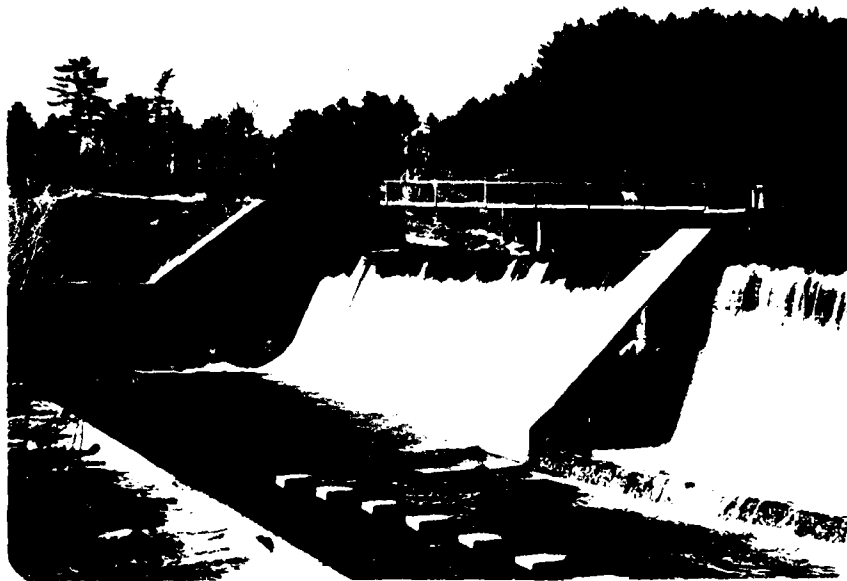
1. Overview of Spillway and Right Embankment

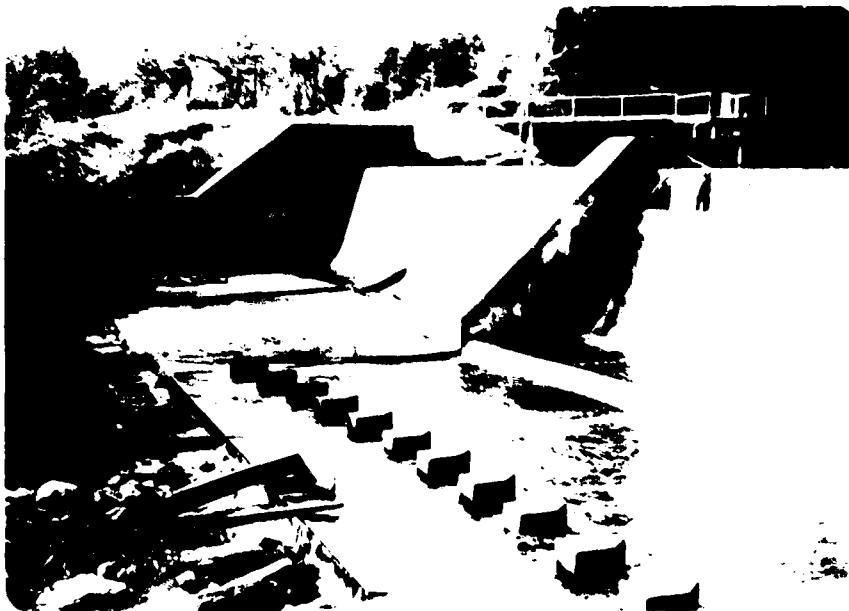
A supplemental inspection was made in June at that time no water was flowing over the right weir, Photo No. 5. The parge coat was found to be in fair condition in the lower region adjacent to the weir and apron. One section approximately 4 ft. long has spalled off exposing the reinforcing mesh. The entire length of the parge coat at the junction of the apron has been undercut. Three drains outlet at the base of the right wall, Photo No. 7. The upstream drain has a small flow of water, the center one was dry and the downstream drain has two plugged pipes just beneath it. Rusty water is seeping from the plugged pipes, Photo No. 8.

The right weir exhibited considerable surface deterioration in the lower region. Several spalled areas are present and the general area appeared to be loose when sounded with a hammer. Two vertical cracks are present. One rises from the main reservoir drain outlet to approximately mid-height of the weir, Photo No. 6. The second is several feet to the left of the first and starts approximately at the elevation of the crown of the outlet pipe and rises vertically to the top of the weir.

5. Right and Left Spillway Weirs Showing Center Pier

Recommendations for remedial work include repair of concrete at the left training wall and right spillway weir and restoration of gates to good operating condition.

Additional investigation of the right spillway weir is recommended, since no data are available concerning this portion of the structure.

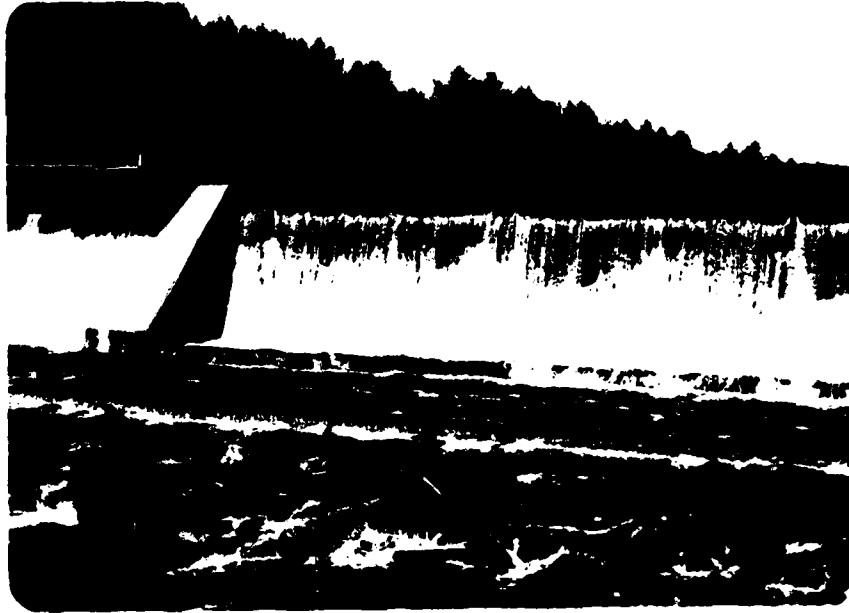
E. Downstream Channel. The channel immediately downstream of the spillways is in satisfactory condition. The floor of the channel is generally covered with cobbles, boulders and broken concrete and the side slopes are paved with large boulders. Islands in the channel floor and side slopes are lightly wooded. These conditions are shown in Photos No. 2, 3 and 9.

9. Left Spillway Weir

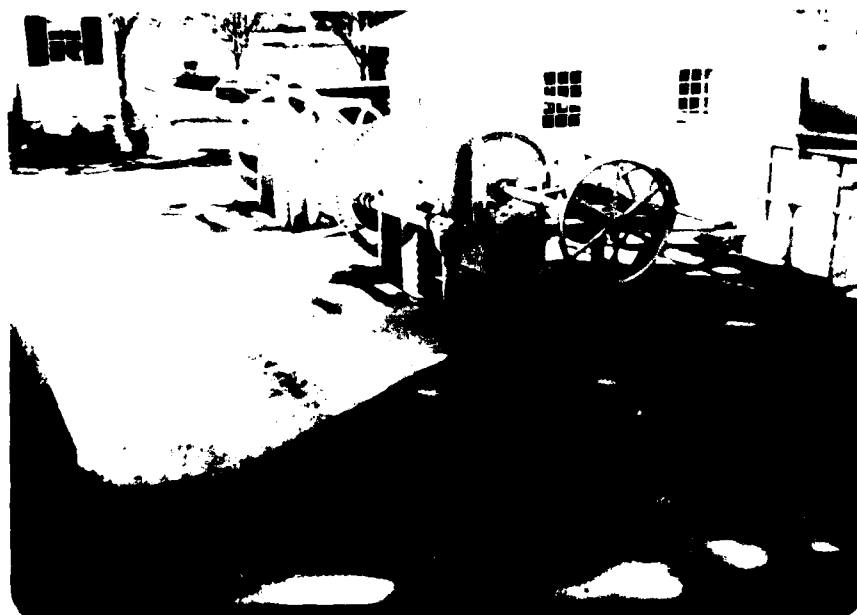
The outlet works structure concrete is in poor condition with spalls, efflorescence, cracks, projecting reinforcement and loose concrete noted. The gates, Photo No. 12, appeared to be operable although they were not tried during the inspection. They were said to be operable.

12. Gates for Outlet Works

The reservoir drains also appear to have received minimum maintenance. It is recommended that the drains be operated at least once a year.
